## *Model A's in WA*

### *1928 SPECIAL COUPE*

### **The Transformation from Roadster to Special Coupe**

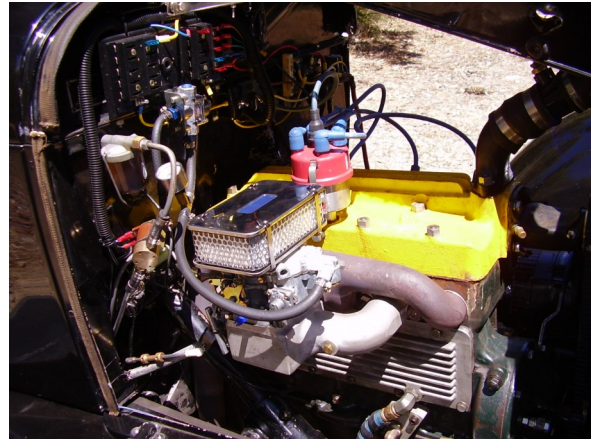
The original solid front engine mount was replaced with the later fork, and the rear mounts were replaced with a float-a-motor kit.
